FOX RIVER LINES

official publication of the
FOX RIVER TROLLEY MUSEUM

THE Restoration of 4451

4451 at Woodcliff

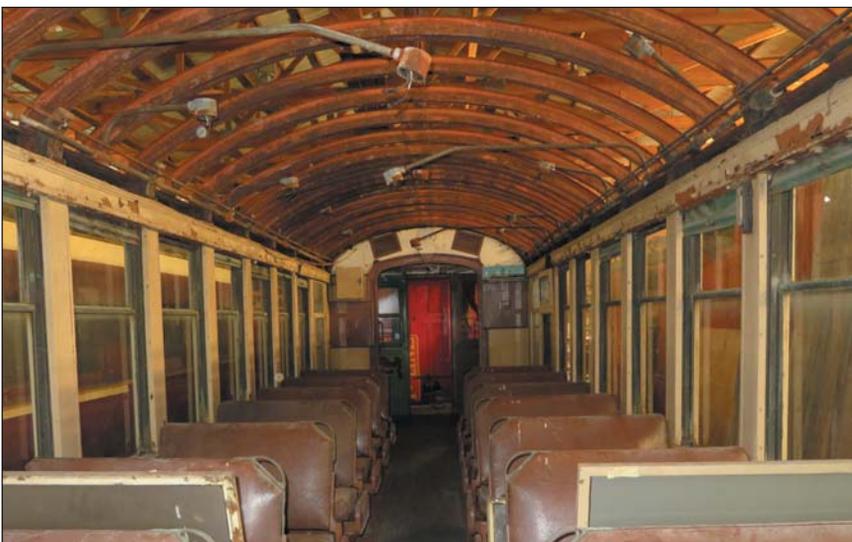
| After the interior ceiling was removed the wooden sandwich members around the metal carlines were also removed as unsupported conduit for light circuits droop down.

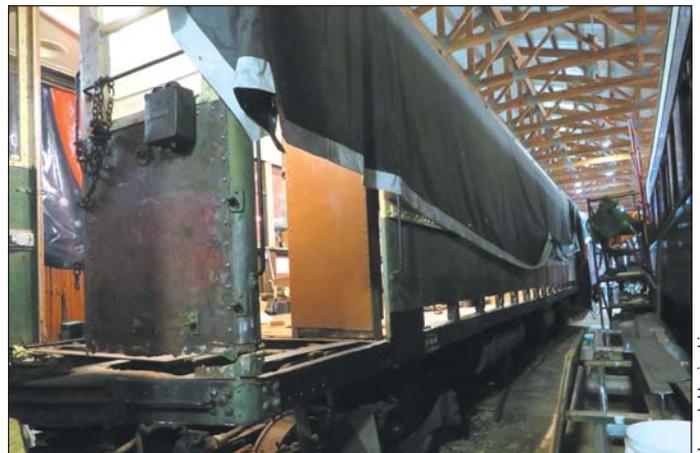
The new roof is covered with a temporary tarp. One can see the bottoms of the corner post and door post which are cut away prior to repair. This is also a good view of the side showing all the bases of the carlines which were repaired.

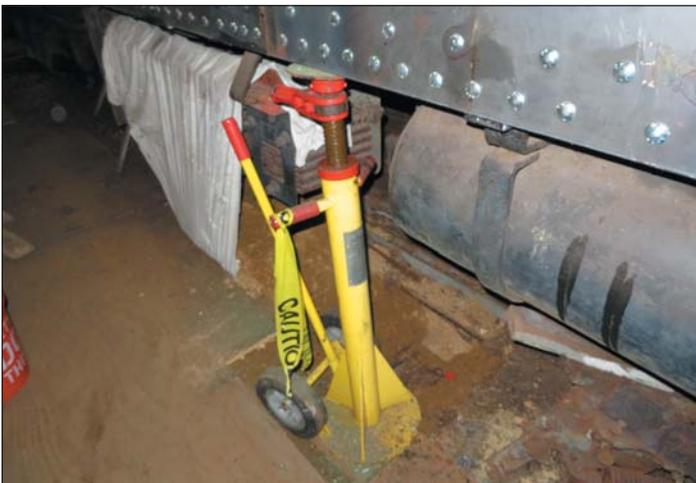
One of the unintended results of removing the bottom eight inches of the side sheets was that the car sagged. To counteract this, car stands were employed to return the proper camber to the side sill.

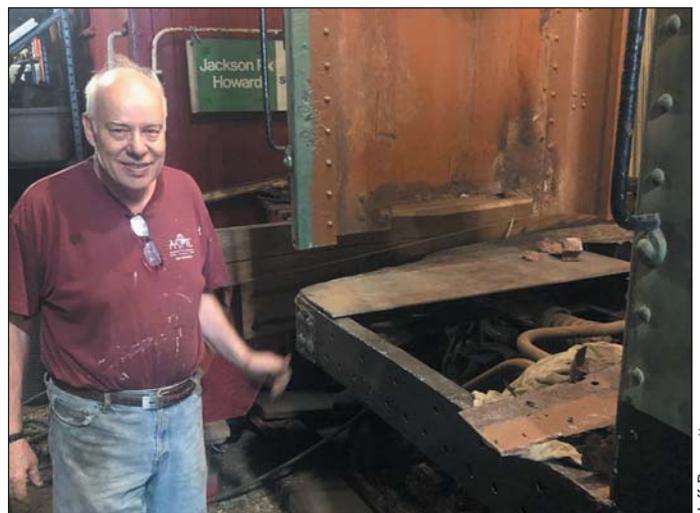
Concurrent with all this side wall metal work, Fred Biederman was working on the rusted under framing and handbrake at the south end of the car.
