FOX RIVER LINES

official publication of the
FOX RIVER TROLLEY MUSEUM

THE Restoration of 4451

4451 at Woodcliff

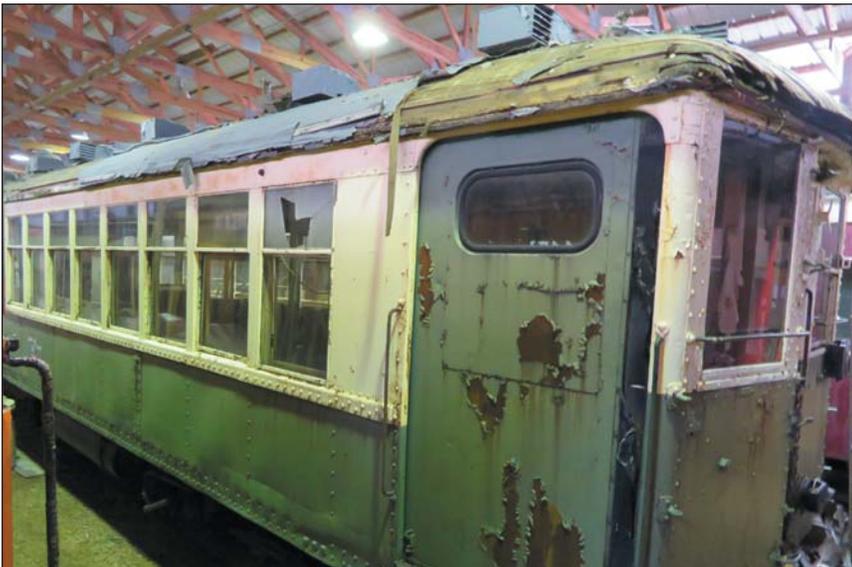
| 4451 has been swapped out for 4288 in the car barn just before work started in April 2018.

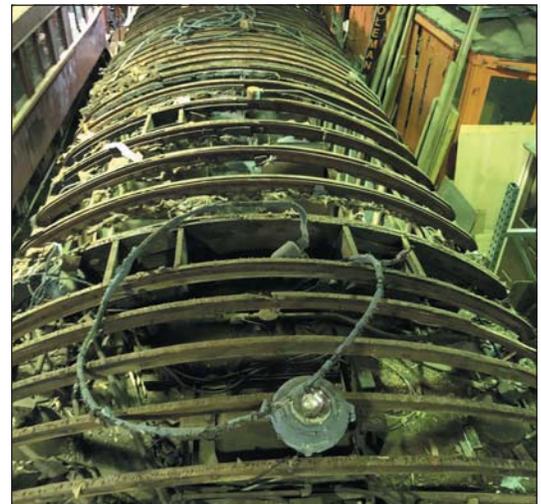
| Removal of the old roof started in earnest shortly after.

sink into the roof and the trolley boards were warping, making moving the car a risky proposition since the pole didn't track very well on the overhead. Its last use was during the 2016 Polar Express™ when scrimms were placed in the mainline facing windows which were then back lighted to give the "North Pole" some more ambiance.

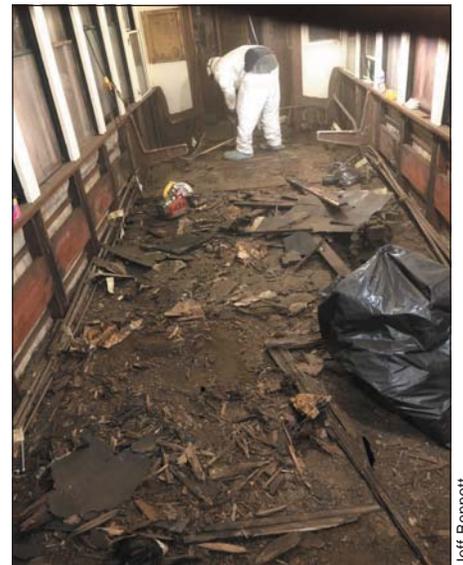
Next the door engines were removed, and the floor was taken up. Seemingly endless plastic bags of debris were hauled out of the car.

With all seating removed the very water damaged wood flooring could be removed, sometimes with a shovel. In the meantime, *Fred Biederman* started working on the car's framing at the south end, replacing major parts of the underframe structure that had severe rust damage. He also took on replacing the chain and pulleys of the handbrake system, parts of which had turned into an unusable rusty mass. Concurrent with this, brothers *Thee and John VanPaseuth* removed and replaced the steel sub floor with all new steel, welding the plates together. As time progressed Jeff cut the bottom eight inches off the side sheets on both sides of the car. This caused the car to sag as the steel side sheets keep the car square, so our screw jack stands, last used on the L-202 motor project, were used to correct the camber of the bottom sills. With this opening, the base of every carline on both sides of the car were cleaned up, weld repaired and painted to inhibit rust, repairing damage which had happened because of the water retained in the wood flooring.

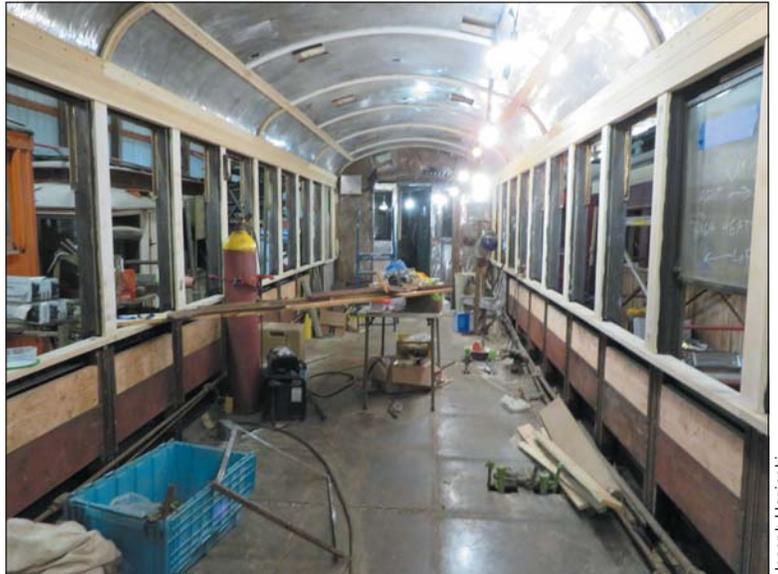
The ceiling panels have all been stripped and new seam moldings have been applied by May 22nd.

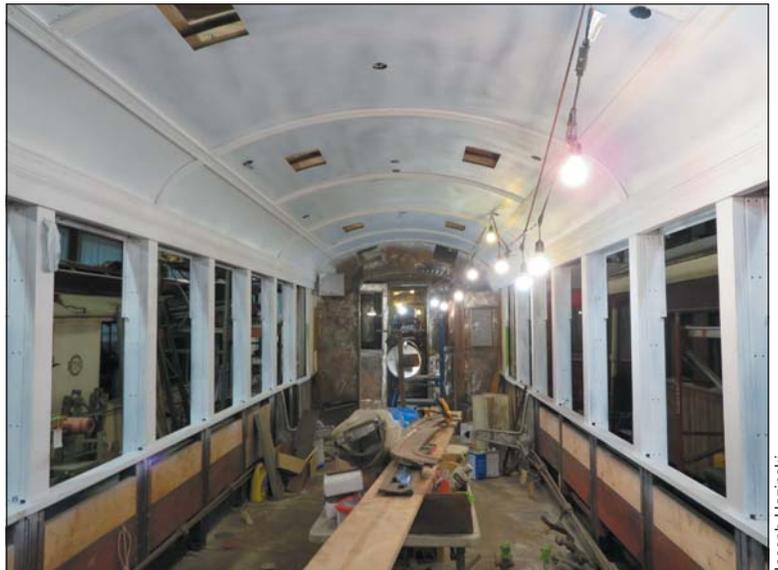
By the end of May the ceiling and upper walls are primed and ready for the finish coat.

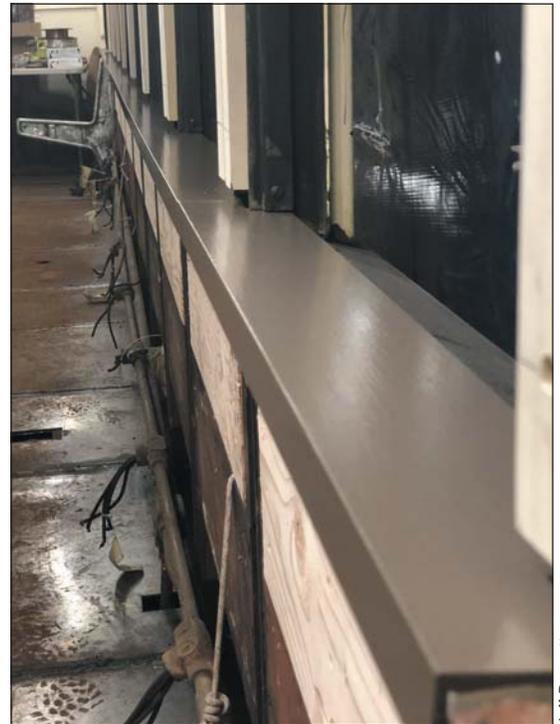
The windowsills were completely replaced as work inside the car continued almost every weekend.

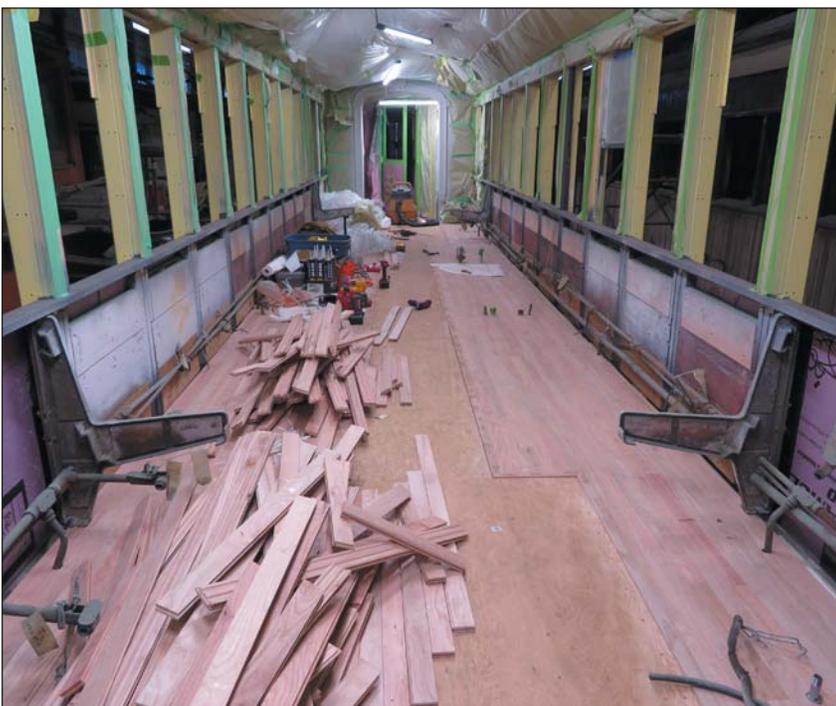
After two layers of plywood have gone down on the metal subfloor, tongue-and-groove flooring is in the process of be installed while work on insulating the walls is being done.

The floor was gradually reconstructed with two layers of marine grade plywood taking the place of two layers of tongue-and-groove that covered the original steel sub floor. Finally, the time came to install the last layer of wood tongue-and-groove flooring in the seating areas. After insulation was installed, new paneling was put in place to make up the interior walls. Interior air brake components were reinstalled and new pipes passing through the floor were replaced at the brake stands in both cabs.

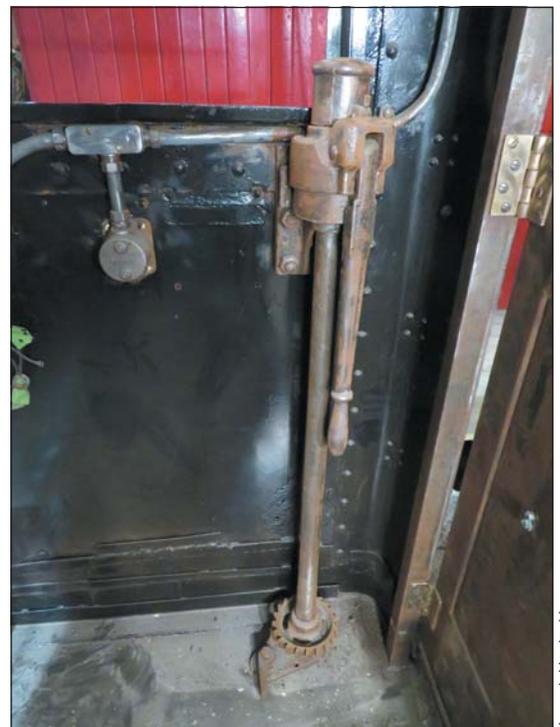
As the steel work in the south or #2 vestibule is complete Fred Biederman has installed the refurbished hand brake staff.

Concurrent with all this side wall metal work, Fred Biederman was working on the rusted under framing and handbrake at the south end of the car.

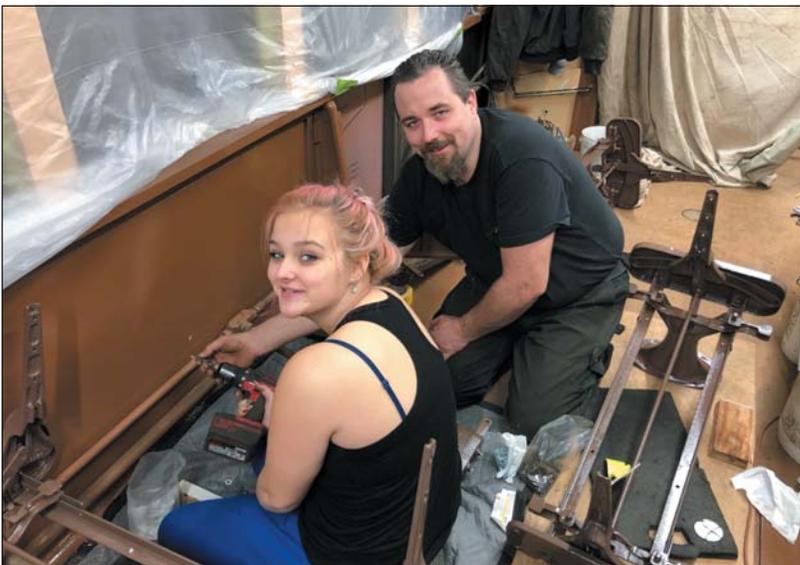
The completely rebuilt heaters have been installed and now Rylee Bennett and father Jeff are installing the seat frames.

By the close of the year all the car heaters were reconstructed with new heater strips and then wired into the car as this had to be done before the refurbished seat frames were carefully installed upon which the heaters are mounted. By January 1st the interior was looking more like it should.

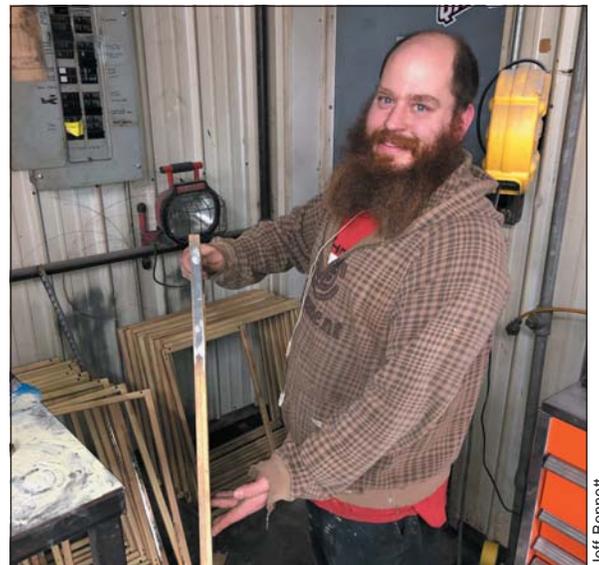
Kyle Kunzer is rebuilding the brass window frames at his shop in Delevan, Wisconsin as 2020 comes to an end.

Kyle Kunzer rebuilt all the side and standee windows that *Thee* and others had carefully disassembled. As some of the brass material had corroded away *Kyle* reverted to the old process of lead repair and then repainted them. Then the windows went off to *LeWalt Glass* in Crystal Lake for glazing. While all this was going on *Jeff* worked on rebuilding the battery charging resistor so that the batteries could once again be recharged. Battery power is necessary for both propulsion control and side door control.

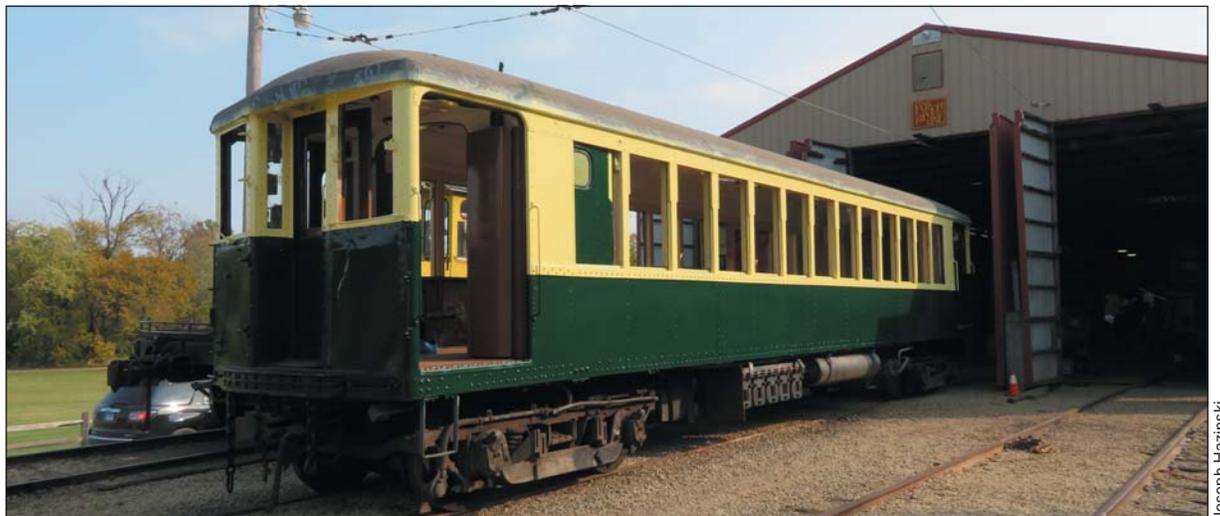
On members day, October 10th, 4451 came outside for display. Note all the windows are out of the car and that the roof is still in need of canvas.

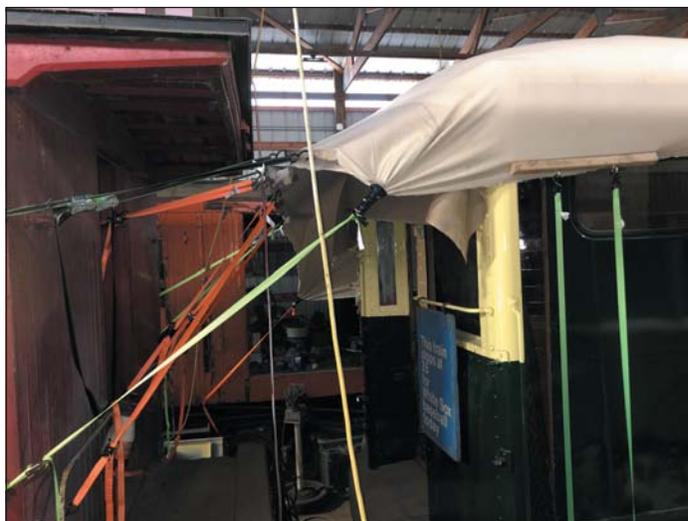
Here is another view of the array of clamps pulling the canvas taut.

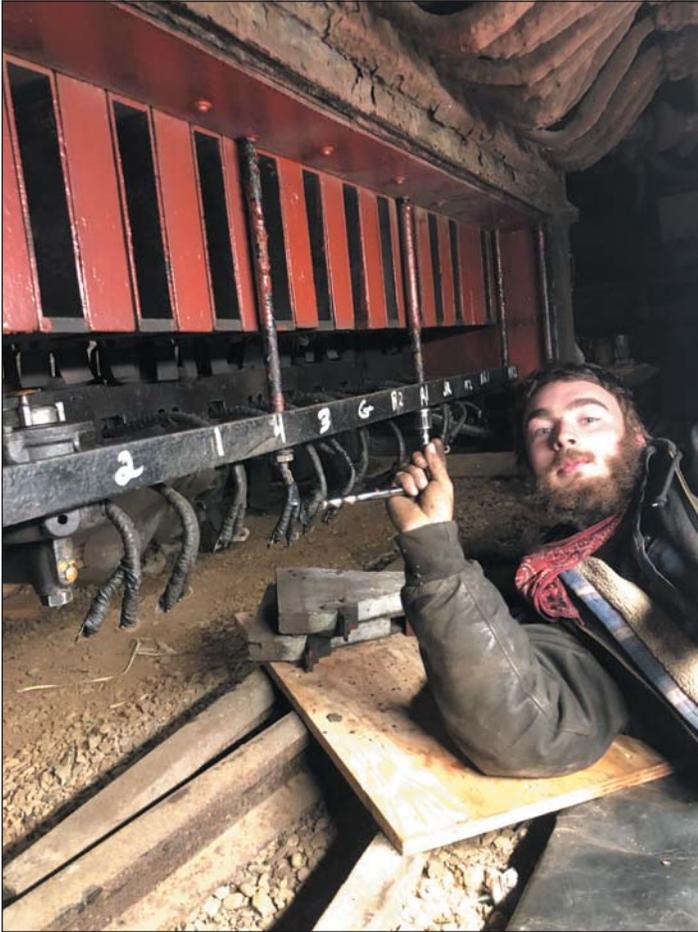
As work progressed on the roof and after the air brake system was put together, Connor Ladley was one several people who went over the magnet valves in the control group.

Meanwhile underneath the car the group switch was inspected with all the magnet valves removed, cleaned and repaired as needed, along with the reverser and motor cut out switch. Once reinstalled the function of the magnet valves were tested with shop air provided by our AC powered carbarn compressor. Group switch access covers were also cleaned up, primed and painted including insulation paint on the inside. All contact tips were inspected cleaned and renewed along with their arc chutes. The air compressor was serviced and the bracket for the U-4 valve portions was cleaned out as air brake components were re-installed inside the car body.

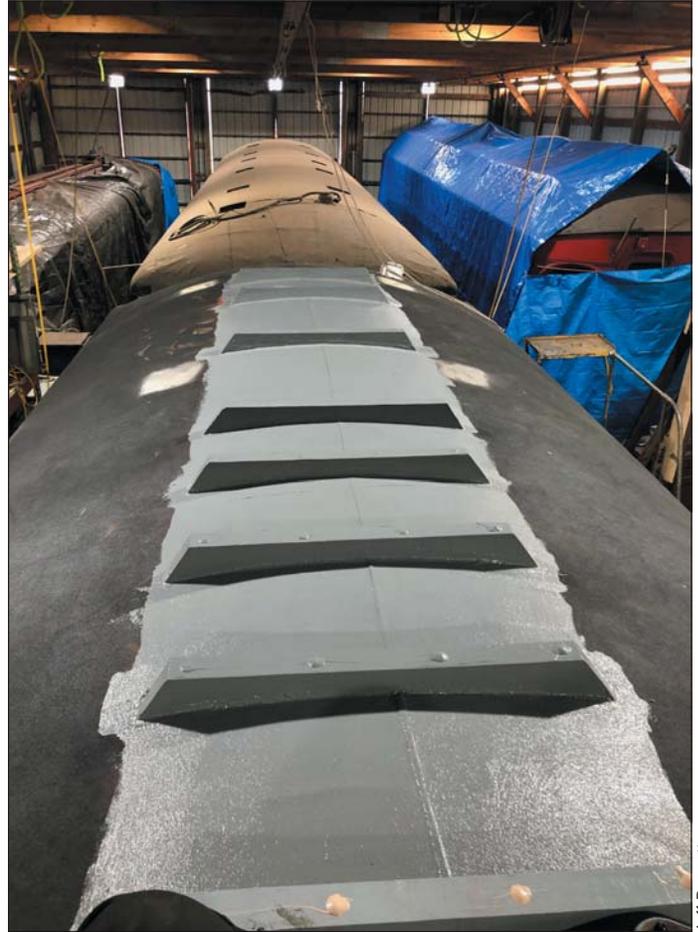
It is April 7th and the saddles for the roof boards have been installed with the finish coat being put down in anticipation of boards being installed.

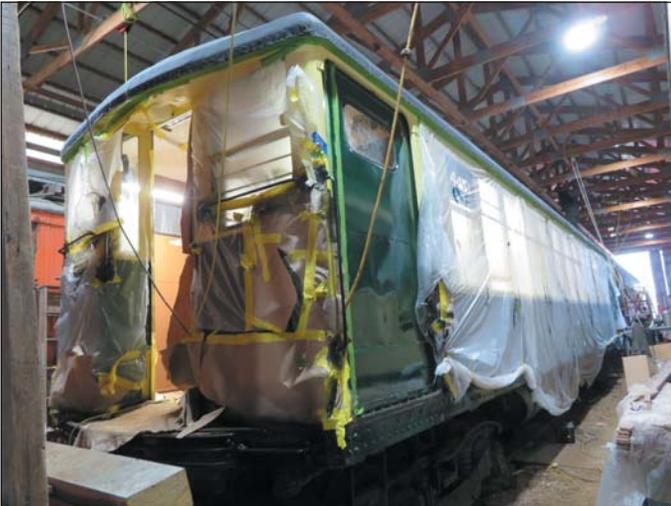
The car was masked with plastic to keep the roof paints off the fresh finish on the sides and ends of the car.

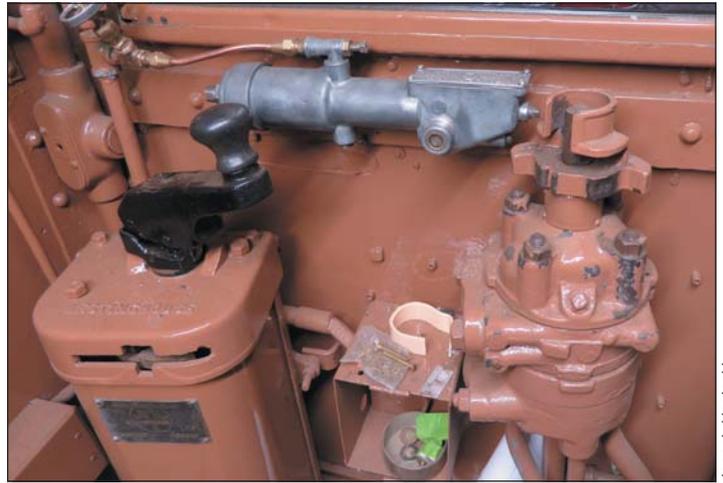
A replacement windshield wiper motor (air operated) was installed at the south end of the car as CTA had disabled this cab during its last years of service on the L.

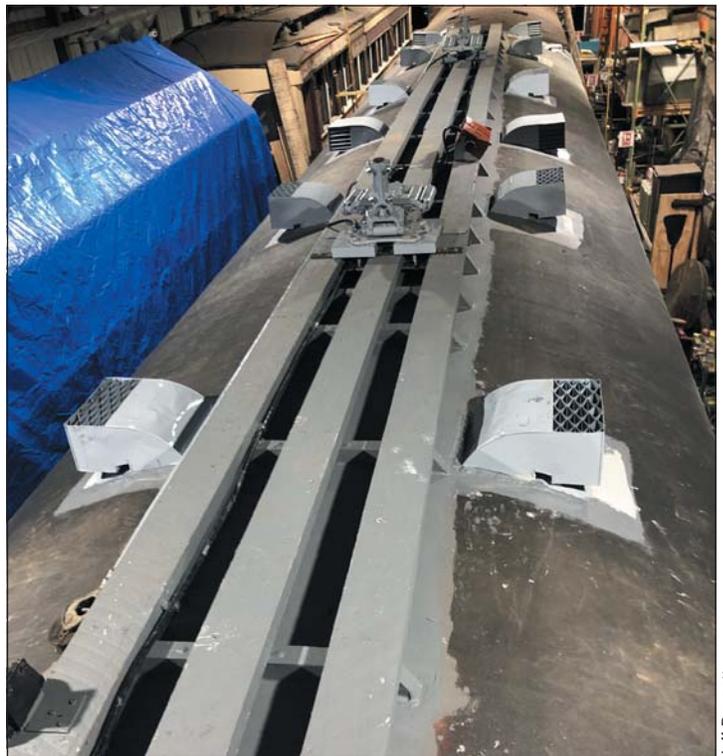
The roof vents, having been cleaned and repainted, have been installed on the car along with the trolley bases and other roof appliances. The finish coat still has to be applied.
